Re: Initial Water Withdrawal Permit Application
Eagle Harbor Sand & Gravel, Inc., Eagle Harbor Mine, NYSDEC Mine ID 80171
Town of Barre, Orleans County, New York

FIGURE 3
Distance-Drawdown
Northeast and Southwest from PW-1A
PW-1A Pumping Test

FIGURE 4
Distance-Drawdown
Northwest and Southeast from PW-1A
PW-1A Pumping Test

Data Analysis and Reporting

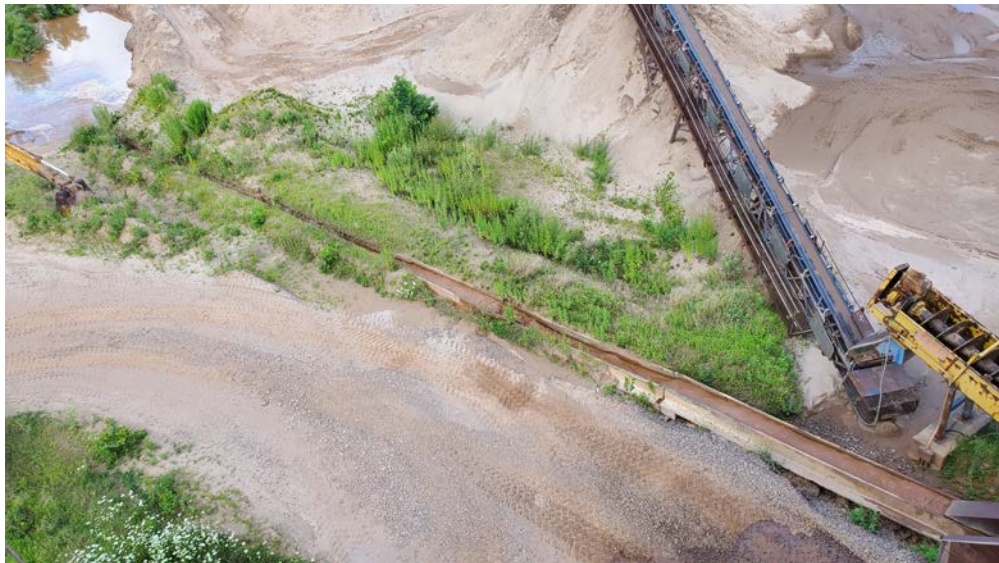
Trough from plant to sediment pond

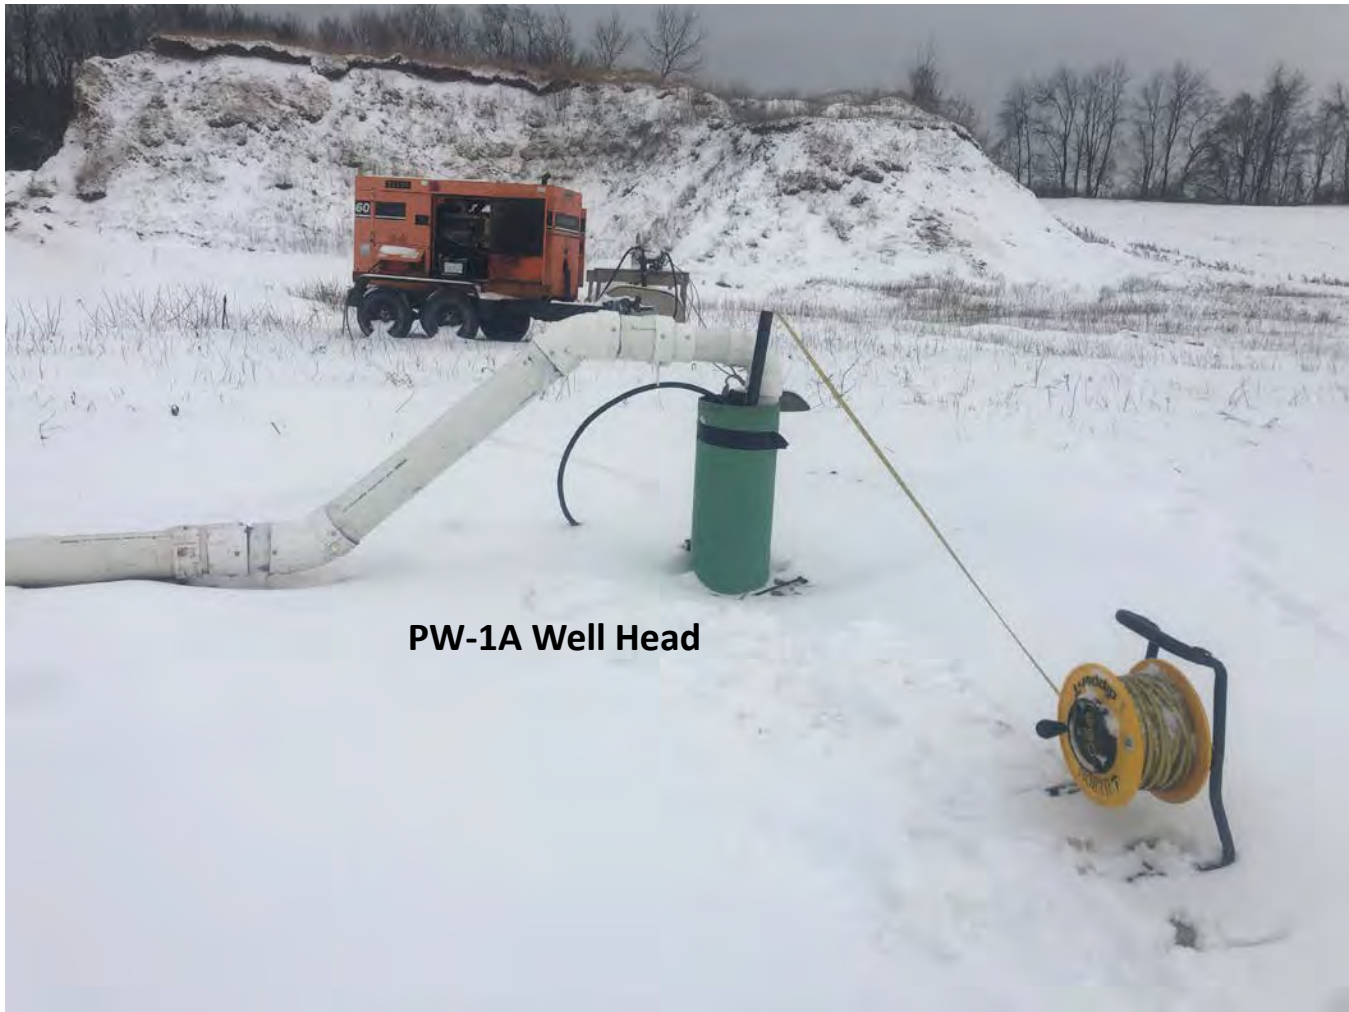
Photograph 1

PW-1A Well Head

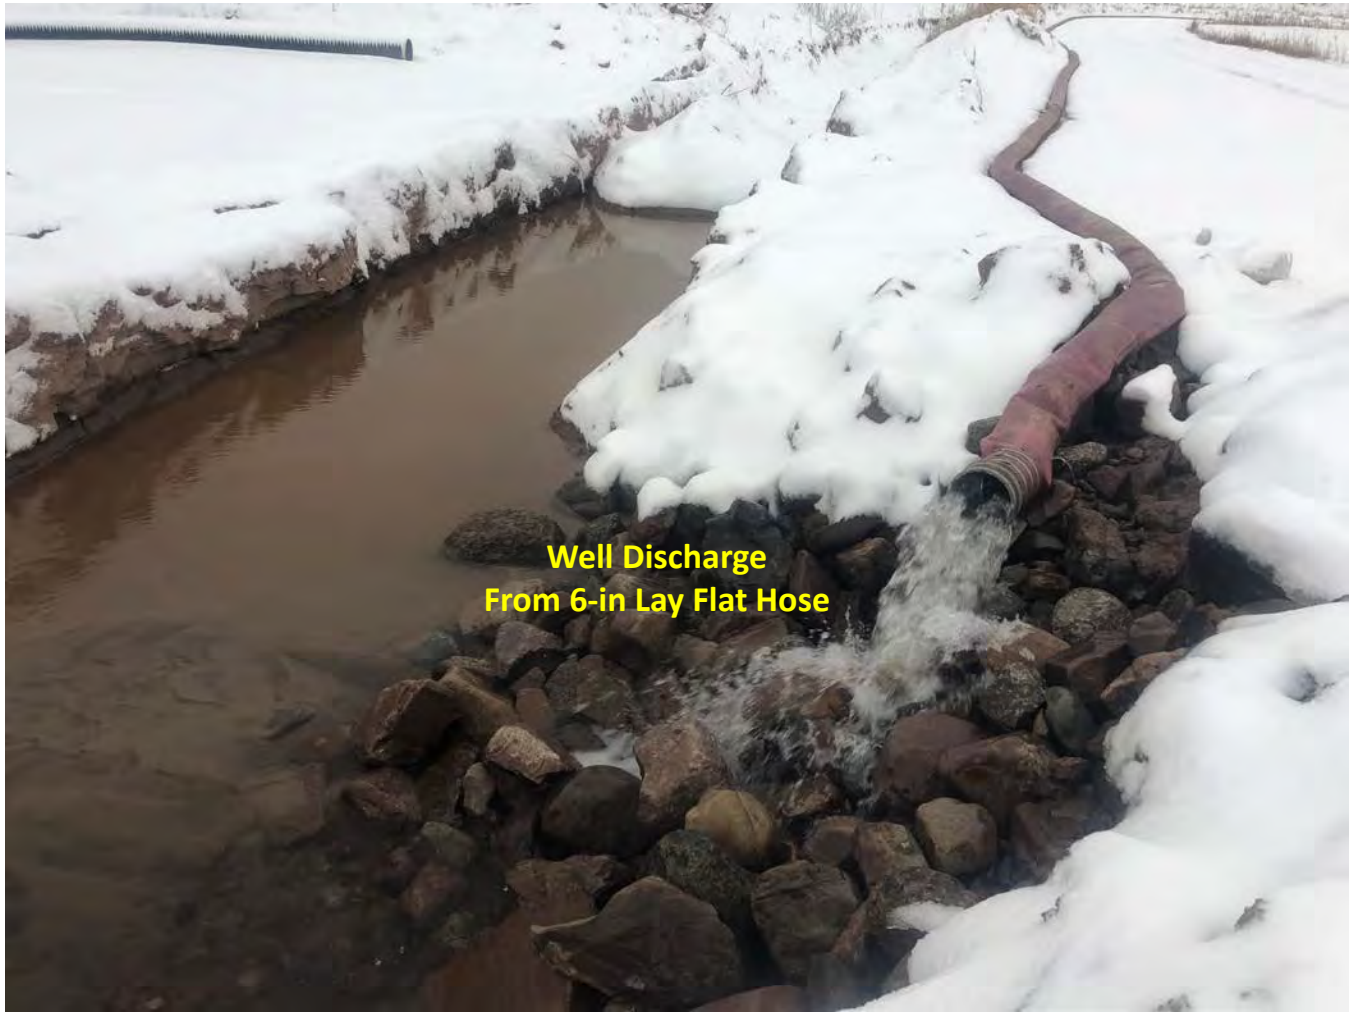
Photograph 2

**Well Discharge
From 6-in Lay Flat Hose**
