January 16, 2020

Mr. Tom Biamonte
Shelby Crushed Stone
10830 Blair Rd
Medina, New York 14103

Re: Wetland Hydrogeology Impact Evaluation
Medina Mine Expansion

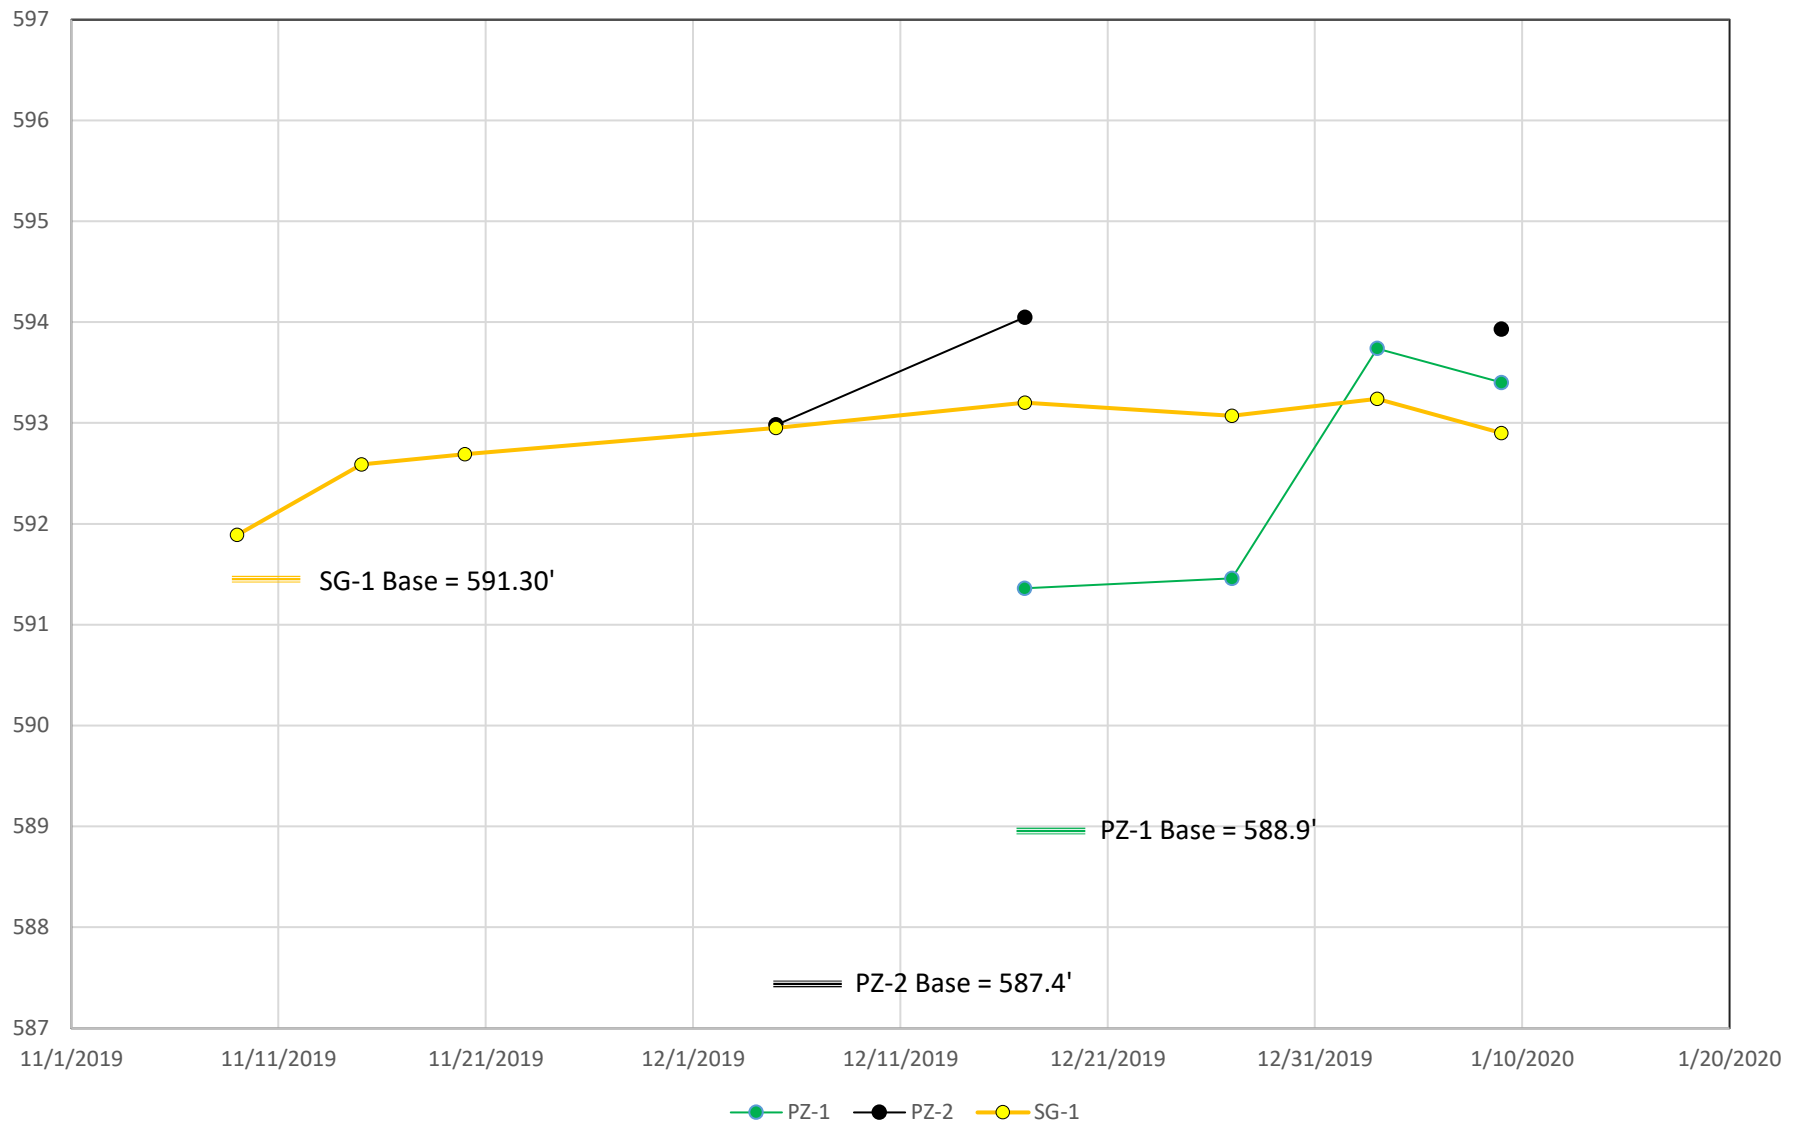
FIGURE 6
MW-6 Water Level Elevations
Shelby Crushed Stone - Medina Mine

Data from bedrock well MW-6, which was located near the present quarry edge, indicates that the ground water table generally stays within the bedrock, separate from the perched water table.

Shelby has monitored water levels in various bedrock monitoring wells at the quarry since 2001. Well MW-6, also known as the Muck Well, was located just inside the LOM boundary (Figure 2) and was installed in 2007 to a depth of 24 ft BGS. Water levels were monitored on a monthly basis there from 2007 until it was mined out in 2016. The hydrograph of the MW-6 water level elevation data is presented in Figure 6. The hydrograph indicates that the water table rarely rose above the bedrock surface during the nine years the well was monitored and never dropped below the Gasport Member (Figure 6). The water table at MW-6 fluctuated up and down seasonally by approximately four to five feet from 2007 until late fall 2105 and early winter 2016 when an apparent downward trend in water levels began as the mine approached the well and ultimately took it out of commission. The southern quarry face was approximately 280 ft from well MW-6 in 2014 and there was no apparent impact to the water level trend in MW-6 at that time.

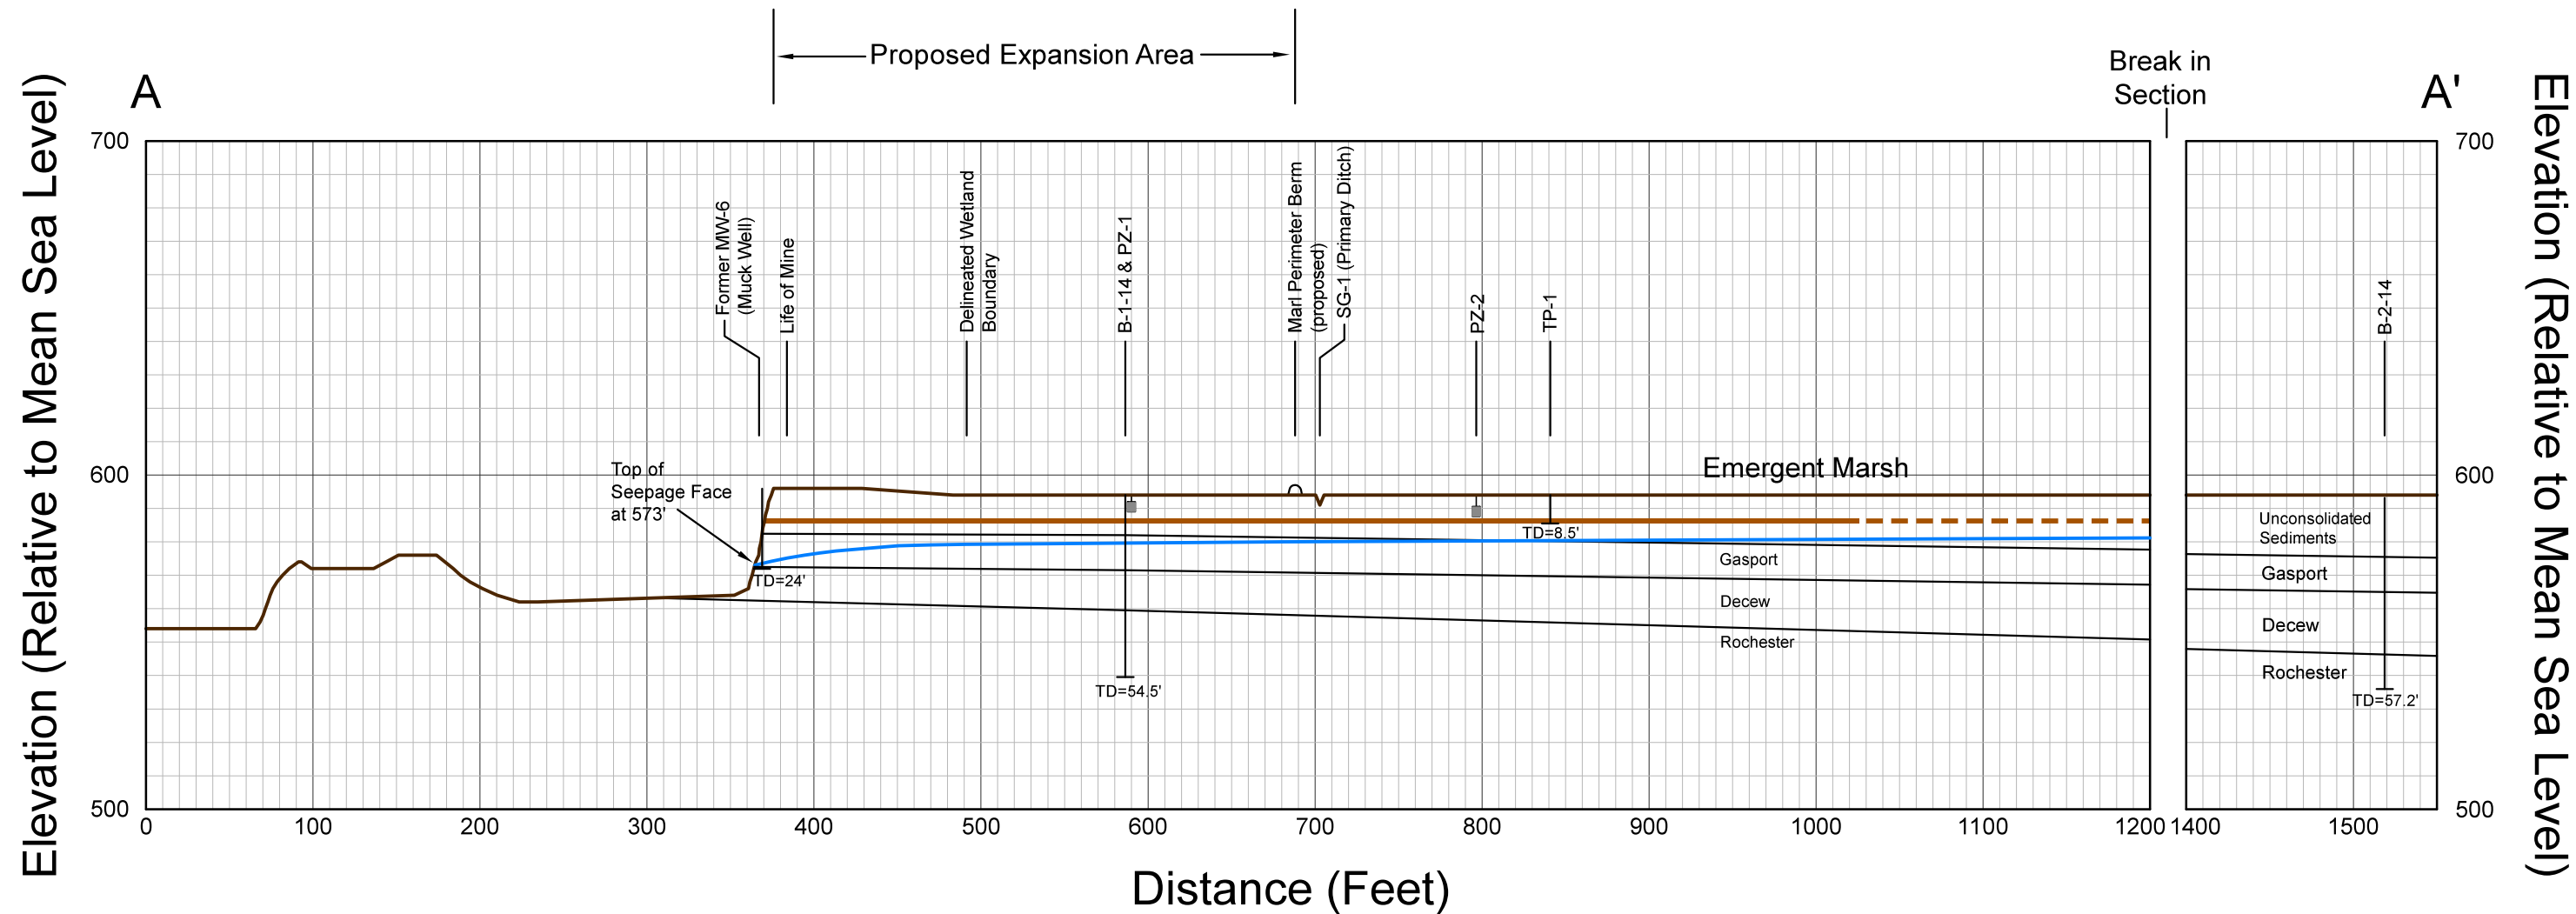
FIGURE 8

Hydrogeologic cross sections were constructed to represent conditions in June 2014, October 2019, and in the future on the last day of mining. The date of June 2014 was chosen because a topographic survey of the mine had been conducted for the mining permit renewal in 2014 and because well MW-6 had water level data available for that month. The cross sections are presented as Figure 7, 8 and 9 and were constructed using information from the following sources:

Section A-A'
2019 Profile
